Manhole Inspection Summary

Manhole # S65G__011MH

Location Address: **6217 Eastern Ave.**

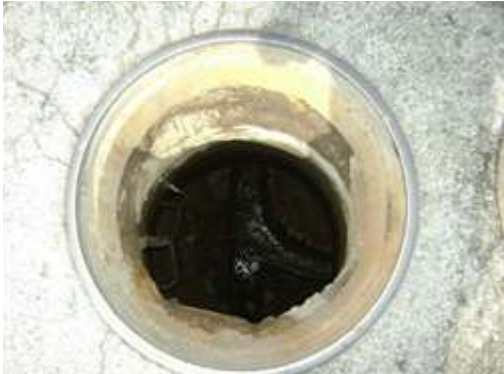
Defect 1

Offset: **3** (in.)

Condition: ☐ Sound ☒ **Cracked** ☐ Leaks

Offset frame

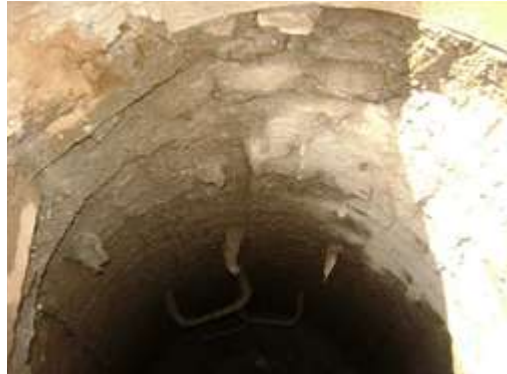
Defect 2

Condition: ☐ Sound ☐ Cracked ☐ Root Intrusion ☒ **Loose Brick** ☒ **Deteriorated**

Infiltration: ☐ None ☒ **Joint** ☐ Cracks ☒ **Mortar** ☐ Roots ☐ Wall

Loose Bricks

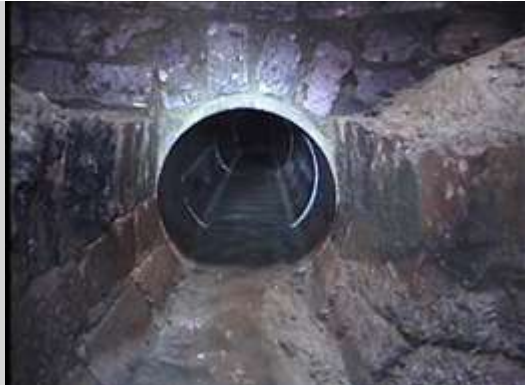
12 O'Clock Outflow

10 in. Circular Gravity Sewer
Pipe Out @ 12 O'Clock

Pipe Height: **9.6** (in.) Rod and Bar (Angled)
Pipe Material: **Clay** ☐ Pipe Lined
Invert Depth: **9.50** (ft.) Flow Characteristics: **Fast**
Deposits: ☒ None ☐ Mud ☐ Sludge ☐ Debris ☐ Grease
Silt Depth: (in.) Deposits Extent:
Infiltration: **None** Pipe Seal Cond: **Sound**

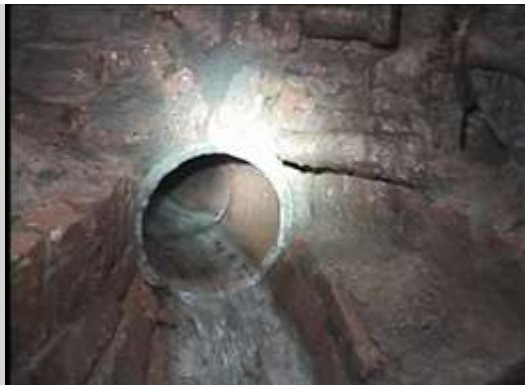
3 O'Clock Inflow

8 in. Circular Gravity Sewer
Pipe In @ 3 O'Clock

Pipe Height: **8.4** (in.) Rod and Bar (Angled)
Pipe Material: **Clay** ☐ Pipe Lined
Invert Depth: **9.33** (ft.) Flow Characteristics: **Fast**
Deposits: ☒ None ☐ Mud ☐ Sludge ☐ Debris ☐ Grease
Silt Depth: (in.) Deposits Extent:
Infiltration: **None** Pipe Seal Cond: **Sound**

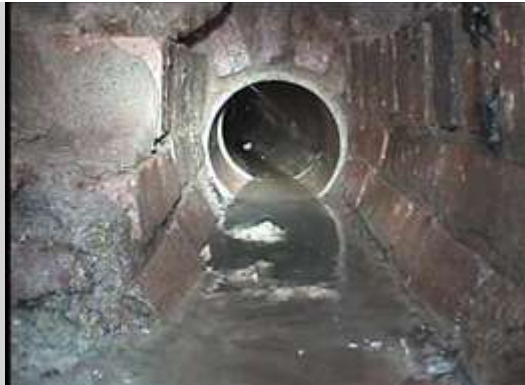
6 O'Clock Inflow

10 in. Circular Gravity Sewer
Pipe In @ 6 O'Clock

Invert Depth: **9.42** (ft.) Flow Characteristics: **Slow**

Pipe Seal Cond: **Sound**
